Manhole Inspection Summary

Manhole # S25CC_046MH

Insp Date: **7/16/07 10:50 AM**

Location Address: **1211 WINCHESTER ST**

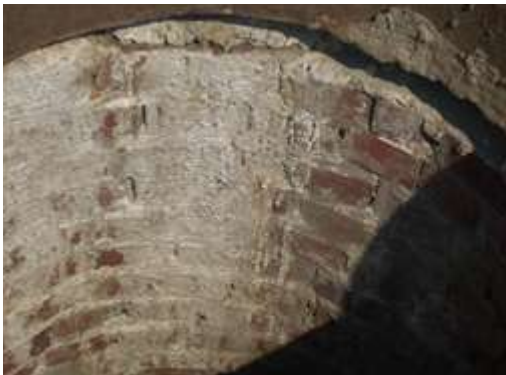
Defect 3

Infiltration: ☐ None ☒ **Joint** ☐ Cracks ☐ Mortar ☐ Roots ☐ Wall

INFILTRATION OF CHIMNEY AT JOINT

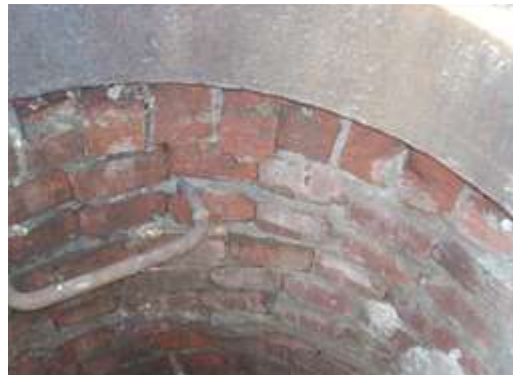
Defect 2

Condition: ☐ Sound ☒ **Cracked** ☐ Root Intrusion ☐ Loose Brick ☒ **Deteriorated**

CRACKED CHIMNEY

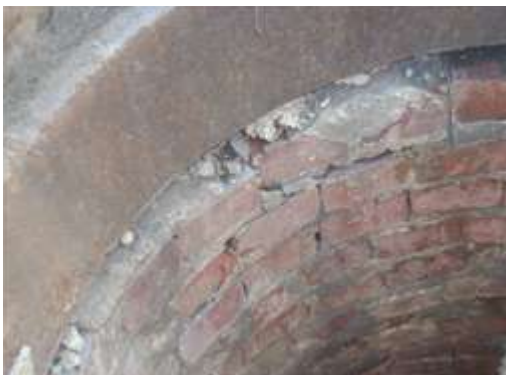
Defect 1

DETERIORASTION OF CHIMNEY

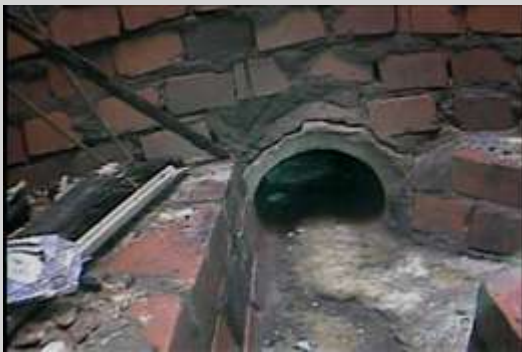
12 O'Clock Outflow

8 in. Circular Gravity Sewer
Pipe Out @ 12 O'Clock

Pipe Height: **7.2** (in.) Rod and Bar (Angled)
Pipe Material: **Clay** ☐ Pipe Lined
Invert Depth: **9.51** (ft.) Flow Characteristics: **Slow**
Deposits: ☐ None ☐ Mud ☒ **Grassy** ☐ Debris ☐ Grease
Silt Depth: **2** (in.) Deposits Extent: **Medium**
Infiltration: **None** Pipe Seal Cond: **Cracked**

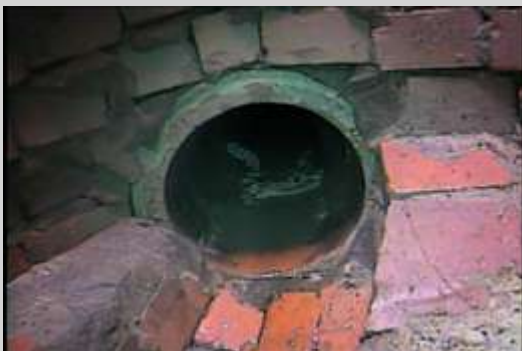
3 O'Clock Inflow

8 in. Circular Gravity Sewer
Pipe In @ 3 O'Clock

Pipe Height: **7.2** (in.) Rod and Bar (Angled)
Pipe Material: **Clay** ☐ Pipe Lined
Invert Depth: **9.04** (ft.) Flow Characteristics: **Slow**
Deposits: ☒ None ☐ Mud ☐ **Grassy** ☐ Debris ☐ Grease
Silt Depth: (in.) Deposits Extent:
Infiltration: **None** Pipe Seal Cond: **Sound**

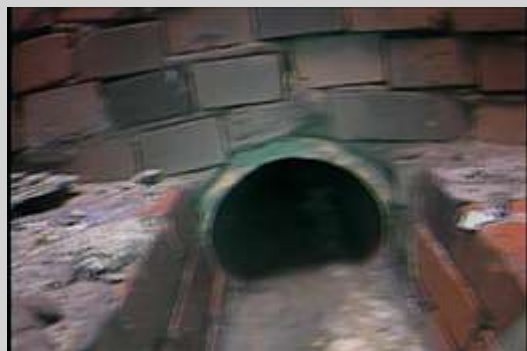
6 O'Clock Inflow

8 in. Circular Gravity Sewer
Pipe In @ 6 O'Clock

Deposits: ☐ None ☐ Mud ☒ **Sludge** ☐ Debris ☐ Grease

Silt Depth: **1** (in.) Deposits Extent: **Light**

Infiltration: **None** Pipe Seal Cond: **Sound**
